**THE AIR ACCIDENT INVESTIGATION  
CENTRAL DIRECTORATE**

**FINAL AIRCRAFT SERIOUS INCIDENT REPORT**

<b>AIRCRAFT TYPE</b>	<b>MD 83</b>
<b>REGISTRATION</b>	<b>SU-BOZ</b>
<b>DATE OF OCCURRENCE</b>	<b>23/06/06</b>
<b>LOCATION</b>	<b>Juba Airport</b>
<b>AIRCRAFT LOCATION</b>	<b>N 04 51 54 E 031 36 33.76</b>

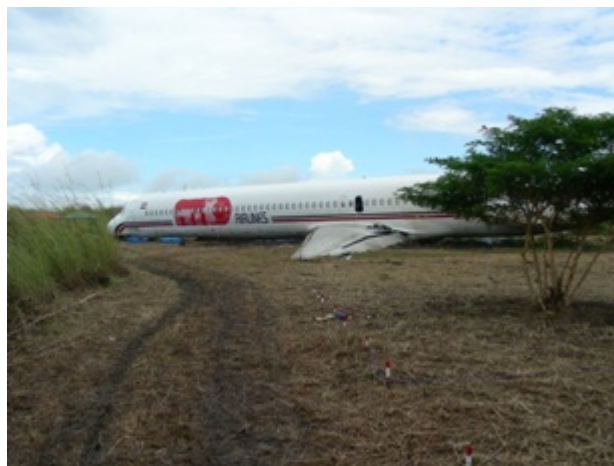
The aircraft landed R/W 31 with landing weight 54 tons and speed of 130 Kts. with reverse being immediately deployed. The touch down point was 752 meters beyond R/W 31 threshold. Five seconds after touch down left wing spoilers suddenly return to stow position and aircraft entered into lateral acceleration condition. The aircraft managed to decelerate to 48 knots, then speed started to increase gradually. Forty eight second after touch down the PIC felt that the aircraft might not come to a full stop he deployed the reverse once again and aircraft speed increased rolling in a curved path to the right and came to total stop about 360 meters ( 1181 feet ) beyond the threshold of R/W 13 ( that is end of R/W 31 ) with left wing touching the muddy ground and retracted nose and left landing gear.

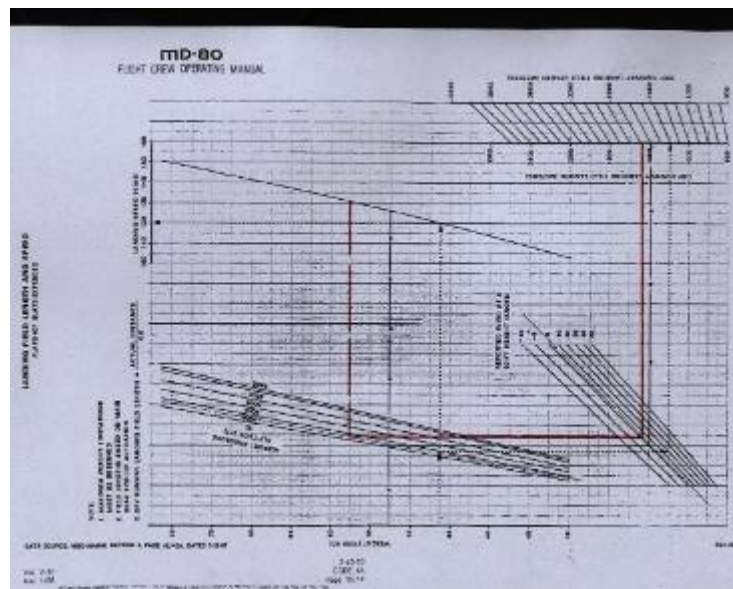
For wet Runway :  $2400 - 1700 - 752 = - 52$  meters off runway

if everything is normal.

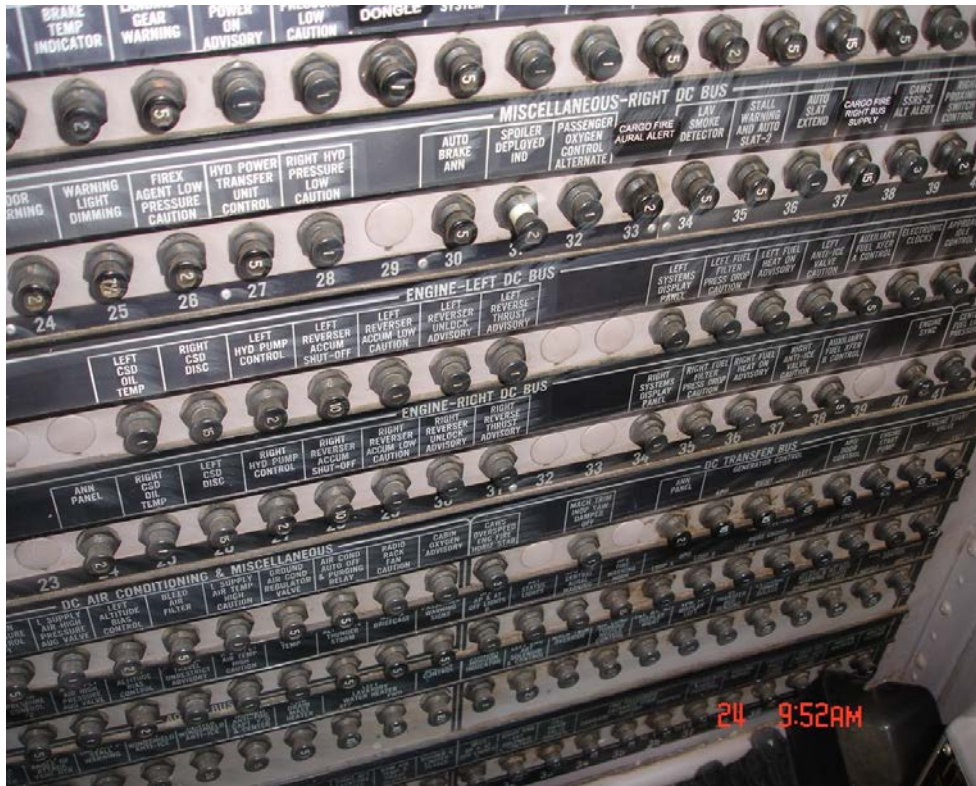
Stowing of left wing spoilers after landing might be due to a malfunction of the selector valve as the circuit breaker in the upper right bus panel found on -off position either due to a short circuit within the unit or its electrical circuit.

Stowing of spoilers might inhibited the automatic brake system without being indicated to the crew and thus automatic brake were not being activated, ( as shown by FDR read-out there was no brake effect within the first seven seconds ) and was disarmed after landing and the aircraft entered in a lateral acceleration which puzzled the PIC and he concentrated all his effort to counteract the lateral acceleration without taking notice of the un-effective deceleration of the aircraft due to insufficient braking action and fast approaching of runway end..
